ENCAPSULATION COLLARS  
FOR UNDER-PRESSURE  
PIPE REPAIR

# ENCAPSULATION COLLARS UNDER-PRESSURE REPAIR OF PIPE SOCKETS AND WALLS

Encapsulation collars are used for safe and permanent repair of all types of pipes and pipe connections while the pipeline is under pressure. Hydro-Cos has developed a wide range of universal and dedicated collars for the repair of pipe sockets and pipe walls, and can also offer completely customised solutions for any leak.

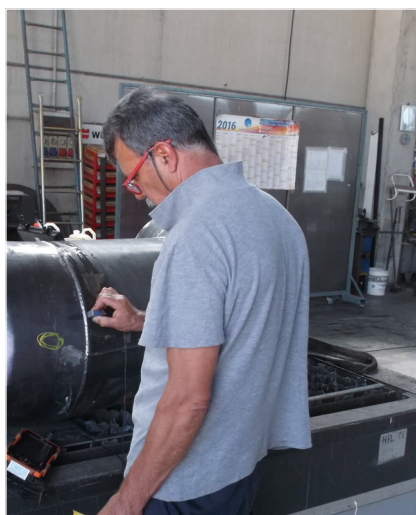
#### Hydro Stop series 8001/2

Pipe encapsulation collar, DN300-2000

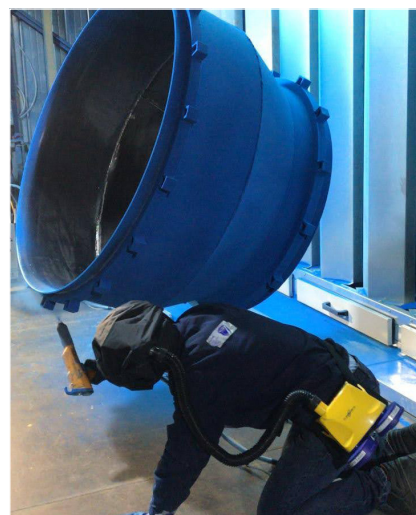
#### Hydro Fast series 8002/0

Socket encapsulation collar, DN300-2000

Hydro Fast encapsulation collars have a tolerance of up to 10 mm on the outside pipe diameter and are dedicated to a specific pipe material. Variants are available for all pipe materials and for both pipe socket repair and pipe wall repair.

- Hydro Fast **socket** encapsulation collars with shaped body accommodate and seal pipe sockets connecting two pipes of the same material.
- Hydro Fast **pipe** encapsulation collars with straight body accommodate and seal slightly misaligned breaks on pipe walls.

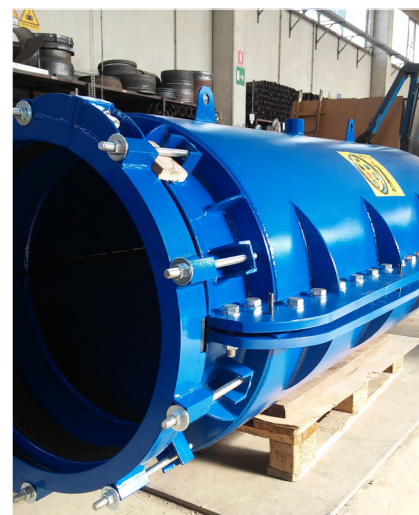
### Hydro Fast

The lightweight compact design is ideal for fragile pipes and limited space on site, and they allow for angular deflection of up to  $\pm 6^\circ$  before or after installation offering great flexibility.

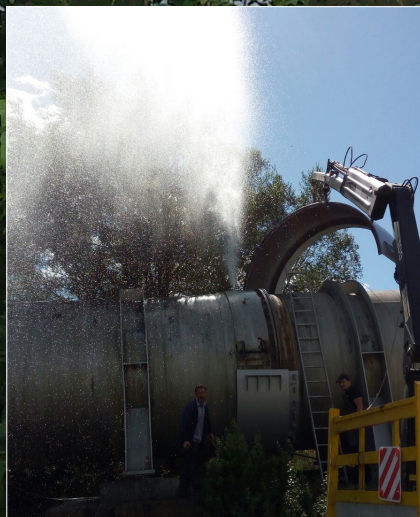
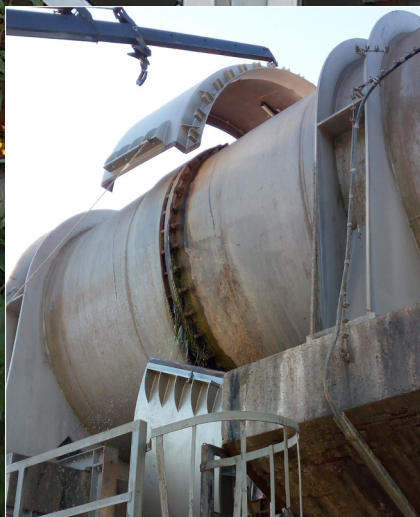
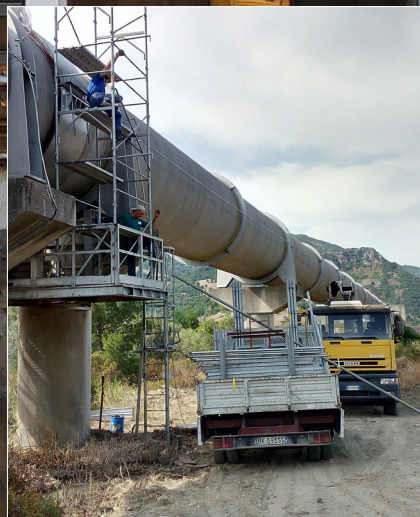
# REPAIR OF EIGHT LEAKS ON THE ADDUTTORE SINNI DN3000 PIPELINE

Hydro Stop socket encapsulation collars used for repairing eight leaks on the largest pipeline in southern Italy.

Basically, the DN3000 flanges that connected the pipes, as well as the expansion joints, were worn out and had started to leak severely. Considering the large population potentially involved in disruption of water supplies, the only possible way to perform any repair was by using our Hydro Stop socket encapsulation collar.

For the eight big leaks, we designed eight different variants of Hydro Stop collars, capable of working not only as encapsulation and repair collars, but also as expansion joints: we offered a product capable of fulfilling two different purposes.

Often, we had to face severe conditions during installation. The most challenging installation was performed in the Montescaglioso district, where the pipeline crossed hillside. This special circumstance caused a pressure increase from the average of 10 to 16 bar up to a peak of 24 bar; a very high pressure for such a large pipeline! Stopping this leak was a real challenge, and we therefore decided to oversize the collar to ensure the highest possible reliability over time.

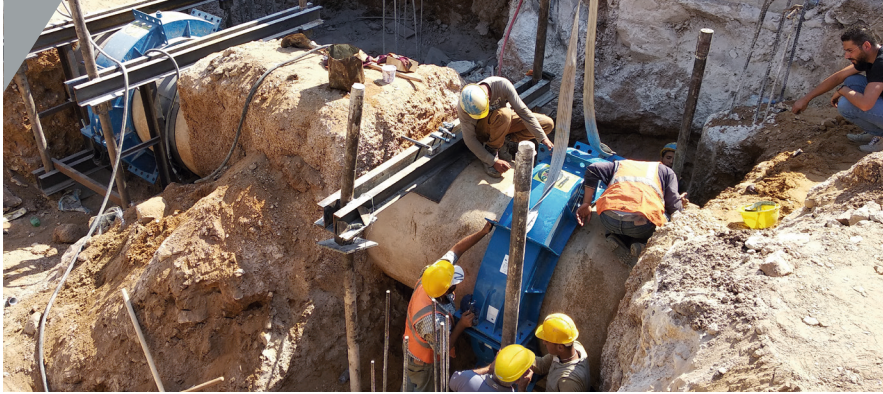
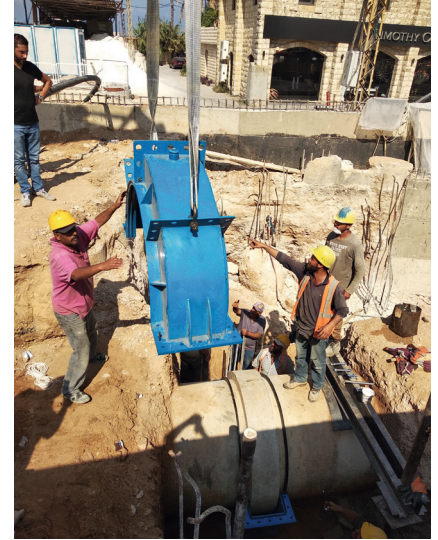
# PREVENTIVE REPAIR OF SOCKET JOINTS ON DN1200 PIPELINE

Hydro Fast socket encapsulation collars used to protect two socket joints on a concrete pipe in Beirut City in Lebanon.

This pipeline crosses the new Jal ed dib overpass, and the pillars of the new flyover were to be built next to the joints, so it was necessary to protect them from possible damage caused by the construction of the pillars. In fact, Beirut Water Authority wanted encapsulation collars for preventive repair of the socket joints.

Because of lack of space on site, a solution with a very short overall length was needed, since the maximum length was restricted to 600 mm. Therefore, we offered our Hydro Fast socket encapsulation collars, as they have no flanges, and the overall length could therefore be reduced to 530 mm.

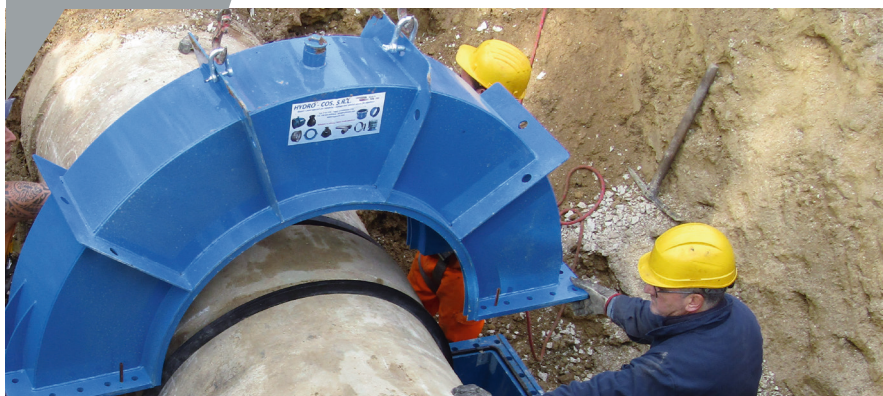
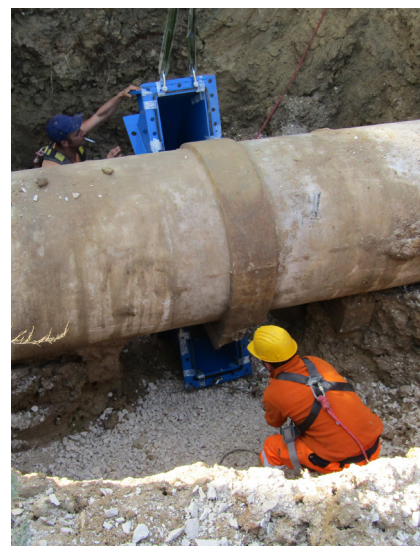
# REPAIR OF SOCKET JOINT ON DN900 PIPELINE

Hydro Fast socket encapsulation collar used for repairing a leaking socket joint on old and fragile concrete pipeline located in Puglia in southern Italy.

The pipe was very old, and some cracks had appeared on its anchor blocks. The anchor blocks were moulded directly on the pipe, so water leaked from the cracks as if it leaked directly from the pipe wall itself.

We had a situation with two problems; the leak itself and a slow collapse of the pipeline because of continuous enlarging of the cracks on the anchor blocks. Two fitters from Hydro-Cos went to the site to study the situation and take measurements. On the upper part, the concrete joint was only 25 mm high, while on the lower part, the height of the joint including the anchor block exceeded 300 mm.

Considering the fragility of the pipe caused by the serious damage to the anchor block, we proposed our Hydro Fast socket encapsulation collar. Because of its light-weight design it would only cause a minimum amount of stress on the damaged pipe anchor. In order to reduce the vertical extension of the collar, we manufactured a DN100 lower flange spigot in the form of a mouth-of-a flute intersection.

After installation, it was only necessary to place two small support devices under the pipe on each side of the concrete joint, to replace the anchor block now encapsulated in the Hydro Fast collar.
